RENASYS[◇] EDGE System utilized to treat non-healing pressure injury wound with history of infection and osteomyelitis in the lower limb

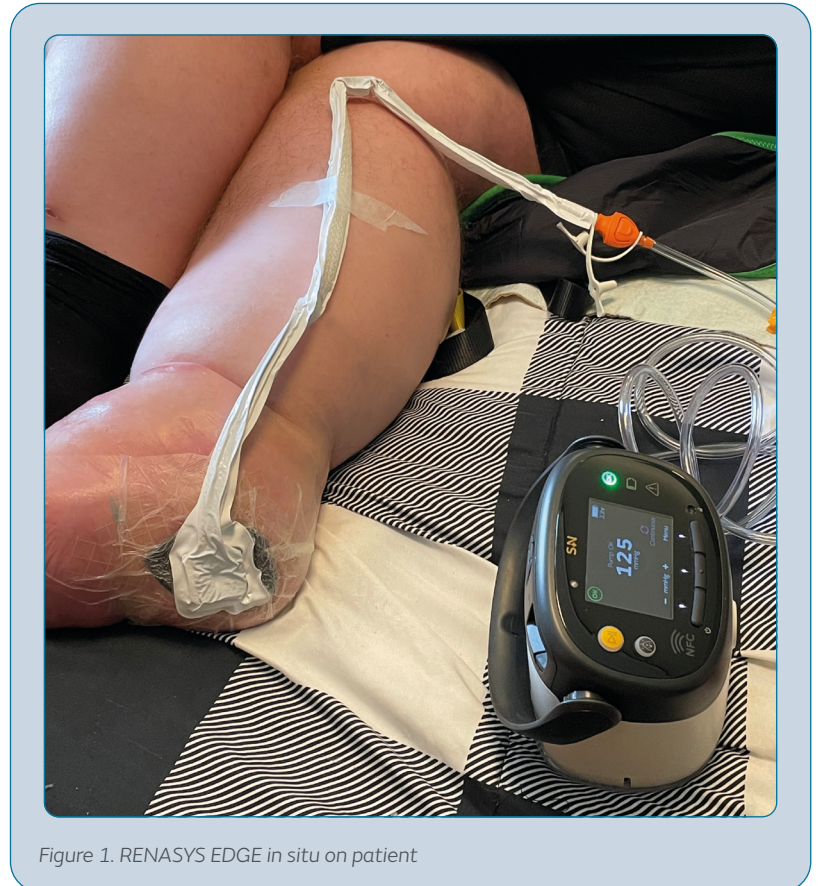
Figure 1. RENASYS EDGE in situ on patient

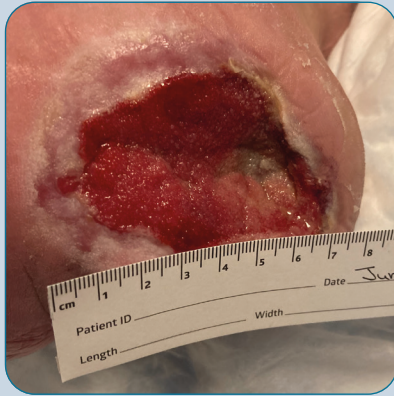
Figure 2

Day 0

Prior to initiating treatment with RENASYS[®] EDGE tNPWT

Wound bed 95% granulation tissue and 5% adipose tissue.

LWD: 7.0 x 5.2 x 1.4cm

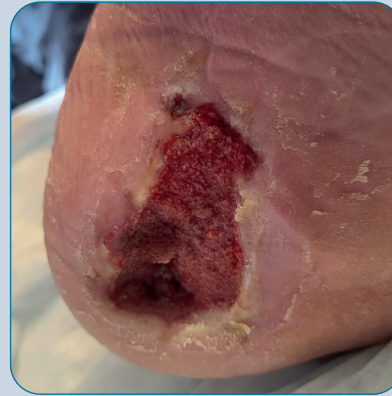
Figure 3

~3 weeks

after initiating treatment with RENASYS EDGE tNPWT

Wound bed 100% granulation tissue.

LWD: 6.0 x 3.5 x 1.0cm

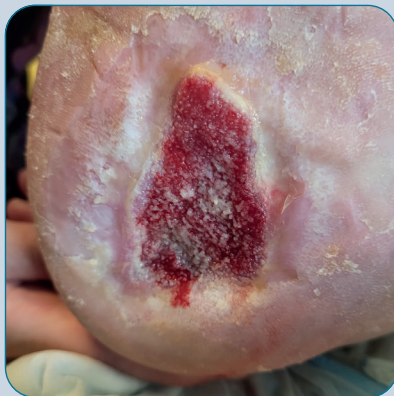
Figure 4

~8 weeks

after initiating treatment with RENASYS EDGE tNPWT

Healthy granulation tissue with increased epithelialization evident.

LWD: 4.8 x 3.2 x 0.5cm

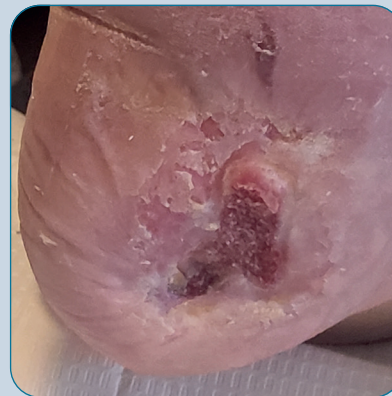
Figure 5

~10 weeks

after initiating treatment with RENASYS EDGE tNPWT

Substantial contraction and reduction in size, wound-bed clean and granulating. Treatment with RENASYS EDGE System stopped and PICO[®] sNPWT initiated.
